Manhole Inspection Summary

Manhole # S23C1_024MH

Insp Date: **7/3/08 1:55 PM**

Location Address: **2421 Huron-Puget st**

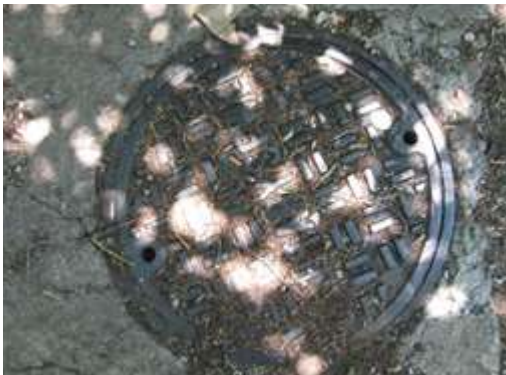
Misc

cover

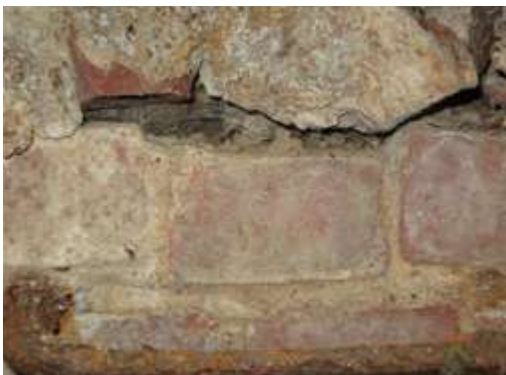
Defect 4

Condition: ☐ Sound ☒ **Cracked** ☐ Root Intrusion ☐ Loose Brick ☐ Deteriorated

cracked chimney

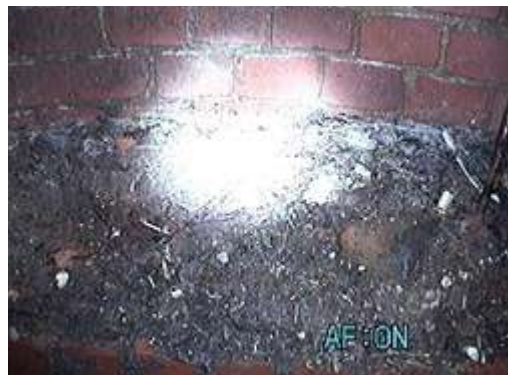
Defect 2

Condition: ☐ Sound ☐ Cracked ☐ Root Intrusion ☐ Deteriorated ☐ Leaks ☒ **Debris**

bench debris

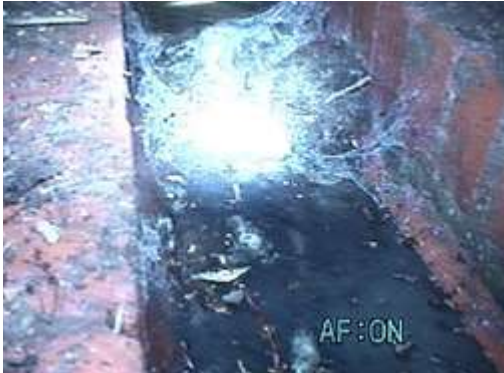
Defect 1

Condition: ☐ Sound ☐ Cracked ☐ Root Intrusion ☐ Deteriorated ☐ Leaks ☒ **Debris**

channel debris

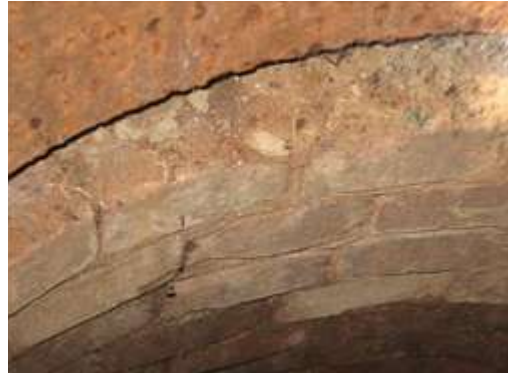
Defect 5

☒ **Leaks**

Infiltration: ☐ None ☒ **Joint** ☐ Cracks ☐ Mortar ☐ Roots ☐ Wall

infiltration from chimney-frame joint

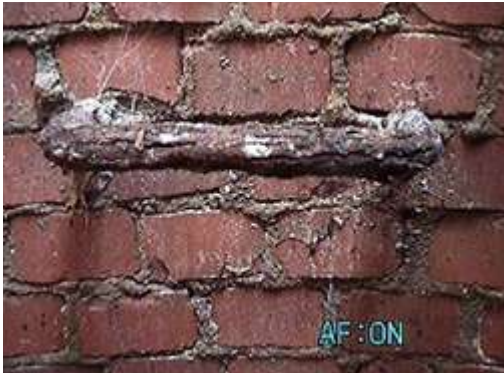
Defect 3

Steps Count: **4** Missing: **0** ☒ **Corroded**

steps corroded

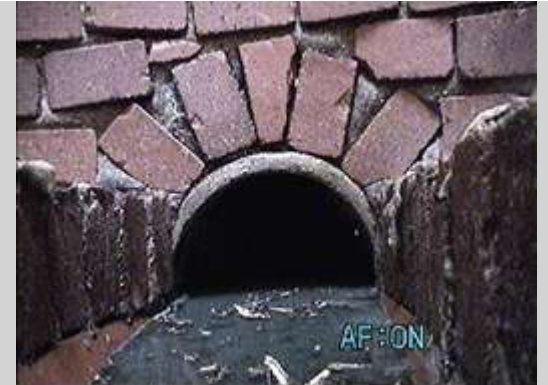
12 O'Clock Outflow

8 in. Circular Gravity Sewer
Pipe Out @ 12 O'Clock

Pipe Height: **8.4** (in.) Rod and Bar (Angled)
Pipe Material: **Clay** ☐ Pipe Lined
Invert Depth: **7.61** (ft.) Flow Characteristics: **Slow**
Deposits: ☒ None ☐ Mud ☐ ~~Sludgy~~ ☐ Debris ☐ Grease
Silt Depth: **0** (in.) Deposits Extent:
Infiltration: **None** Pipe Seal Cond: **Sound**

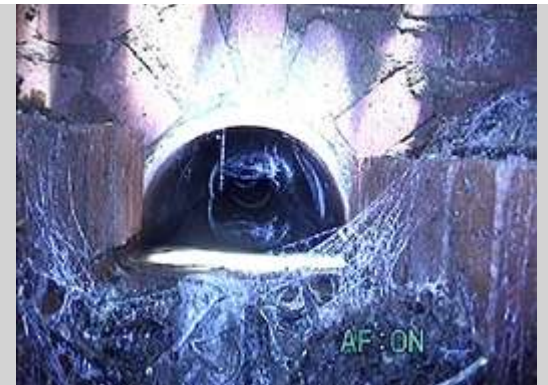
6 O'Clock Inflow

8 in. Circular Gravity Sewer
Pipe In @ 6 O'Clock

Pipe Height: **8.4** (in.) Rod and Bar (Angled)
Pipe Material: **Clay** ☐ Pipe Lined
Invert Depth: **7.52** (ft.) Flow Characteristics: **None**
Deposits: ☐ None ☐ Mud ☒ ~~Sludgy~~ ☐ Debris ☐ Grease
Silt Depth: **2.5** (in.) Deposits Extent: **Heavy**
Infiltration: **None** Pipe Seal Cond: **Sound**
